Contract #: 04-0120F4Cty: SF/Ala Rte: 80 PM: 13.2/13.9File #: 69.28**WELDING INSPECTION REPORT****Resident Engineer:**Siegenthaler, Peter**Address:** 333 Burma Road**City:** Oakland, CA 94607**Report No:** WIR-019608**Date Inspected:** 01-Jan-2011**Project Name:** SAS Superstructure**OSM Arrival Time:** 1900**Prime Contractor:** American Bridge/Fluor Enterprises, a JV**OSM Departure Time:** 700**Contractor:** Zhenhua Port Machinery Company, Ltd (ZPMC), Changxing Island **Location:** Shanghai, China**CWI Name:** See below**CWI Present:** Yes No**Inspected CWI report:** Yes No N/A**Rod Oven in Use:** Yes No N/A**Electrode to specification:** Yes No N/A**Weld Procedures Followed:** Yes No N/A**Qualified Welders:** Yes No N/A**Verified Joint Fit-up:** Yes No N/A**Approved Drawings:** Yes No N/A**Approved WPS:** Yes No N/A**Delayed / Cancelled:** Yes No N/A**Bridge No:** 34-0006**Component:** OBG Components**Summary of Items Observed:**

# WELDING INSPECTION REPORT

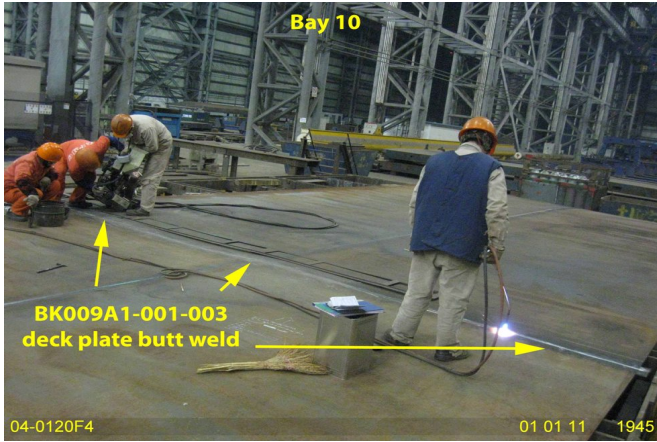
SAW welding of butt weld joint BK009A1-001-003 located on PCMK OBG BK009-001, deck plate. Welder was identified as 050295. QC was identified as ZPMC CWI ZPMC CWI Fu Guo Gang (QC2). Assisting QC2 at this location and appearing to be monitoring the welding operation and recording data was ZPMC QC Deng Zhi Bing (QCA2), who was not a CWI. Weld variables recorded by QCA2 appeared to comply with WPS-B-T-2221-B-L2c-S-2 as verbally identified by QCA2. See the photo below showing flame heating of weld joint to maintain interpass temperature as the SAW welding operation proceeds at the other end of the weld joint.
